### **36. Site 36 at RM 217.5 RDB (Pool 26)**

### **36a. Observation Site at RM 200.2 RDB (Pool 27)**

### ***37. Site 37 at RM 197.6 RDB (Pool 27)***

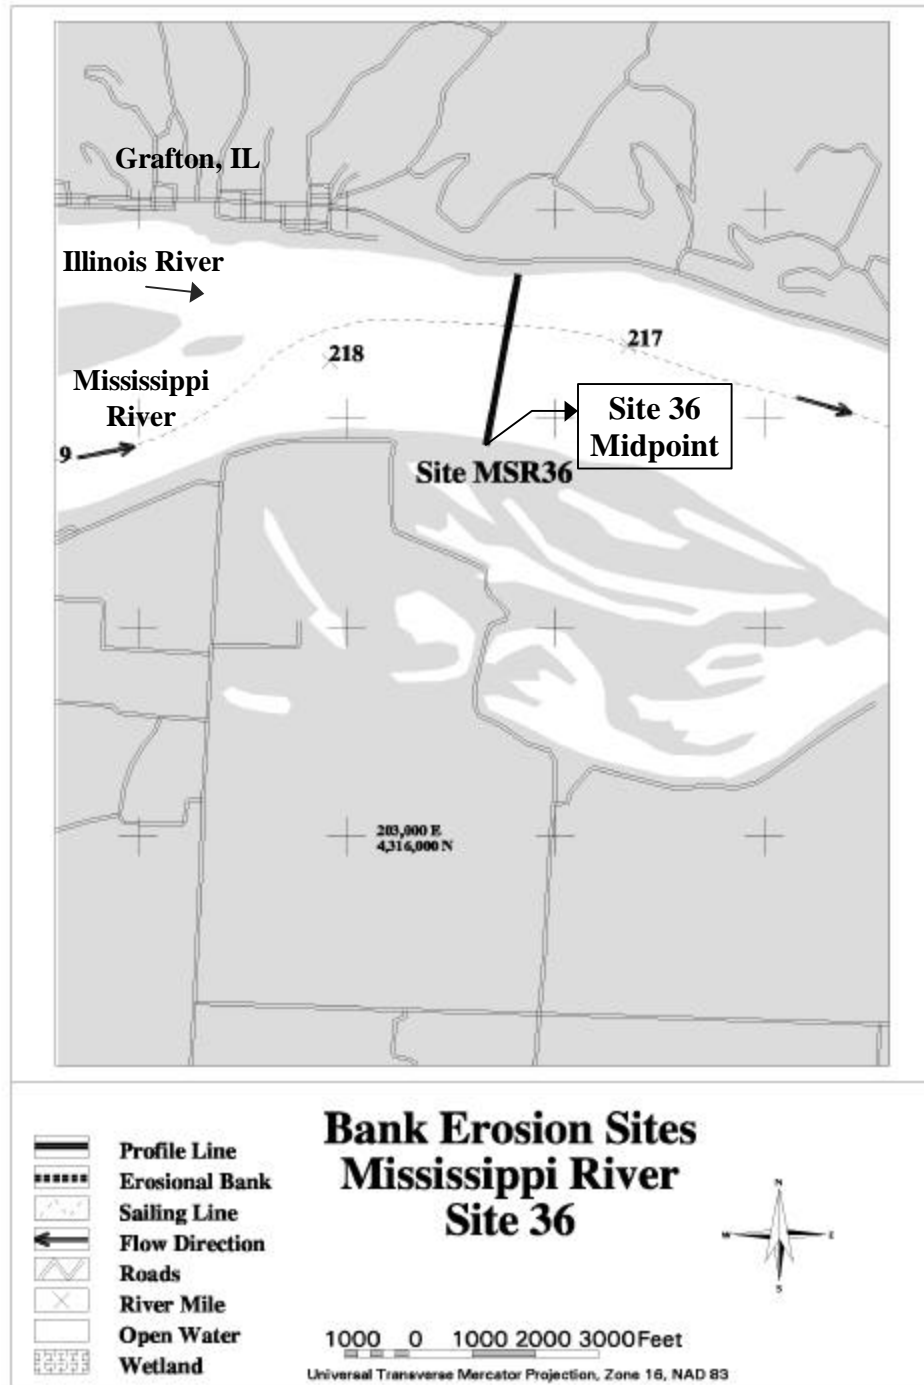
Figure 7-118 A map showing Mississippi River Site 36

This right-bank site, shown in figure 7-118, is located along a rather straight reach, just 0.5 mile downstream from the confluence of the Illinois River, 14.6 miles upstream from Lock & Dam No. 26. Photo 7-87 shows a downstream view of the site, and Photo 7-88 shows a close-up view of the scarp. The bank section taken is shown in figure 7-119. The river cross section indicates that the site is located in the convex bank of a minor bend. At the top of the bank is a farm field, and some segments of a local road were found to be collapsing due to bank retreat. The bank soils consist of fine to medium silt (FST-MST) and fine sand (FS). Subaqueous sediments are fine sand (FS).

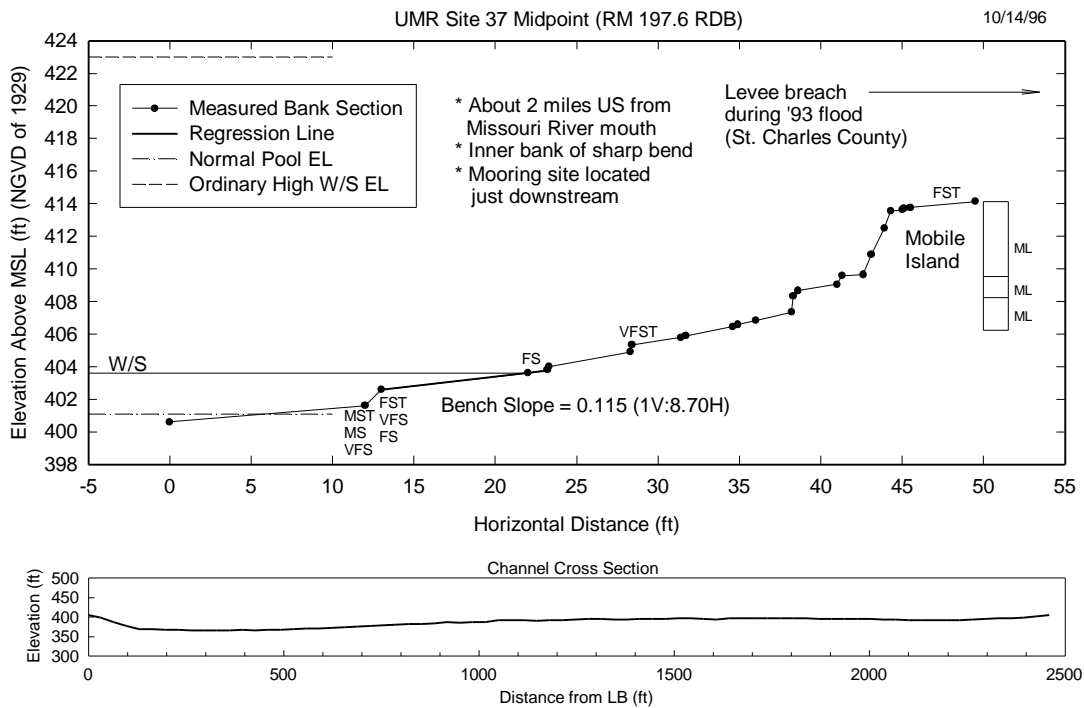
**Figure 7-121 Bank section and channel cross section measured at Site 37 midpoint**

This right-bank site on the inside of a sharp bend, shown in figure 7-120, is located less than 3 miles upstream from the Missouri River confluence at RM 195. Bank retreat since 1984 is evident in figure 7-120. Photos 7-91 and 7-92 show upstream and close-up views of the site, respectively. The bank section taken is shown in figure 7-121. The river cross section in figure 7-121 shows topography representative of the sharp bend along the site. The bank soils are primarily silt. The site is far from the thalweg sailing line. There is a barge-mooring site immediately downstream from the erosion site. There are several scarps within the bank. The levee along Mobile Island was overtopped during the Great Flood of '93, and this site is located where a breached portion of the levee was being repaired.

As at Site 36, causative factors for bank retreat at this site include flood-flow erosion and recessional failures, piping and collapse, slaking, overland flows, and wave and rework transport of failed soils and recently deposited sediments in bench areas. Due to nearby fleeting activities, more extensive wave erosion occurs at this site. Type C best characterizes Site 37.
